# MESURED SURVEY OF BLACKWATER QUAY

TECHNE STUDIO F

BREIF 1

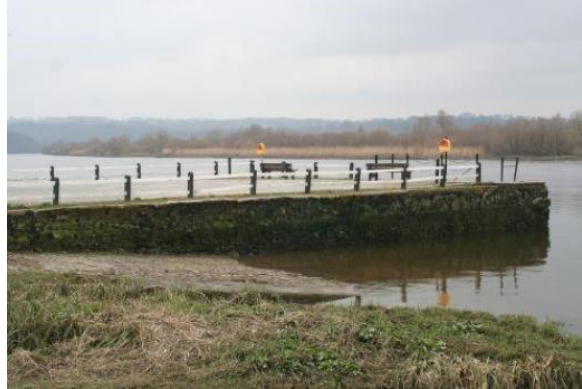
The area is well used as the Boating and Activity Club is located adjacent. Nevertheless, materials are eroded, and vegetation is overgrown, these factors could represent a hazard for safety. (1)

Figure 5: Erosion and vegetation overgrowth (<https://irishwaterwayshistory.com/abandoned-or-little-used-irish-waterways/waterways-of-cork-and-kerry/the-bride-the-munster-blackwater-and-the-lismore-canal/the-blackwater-by-road/villierstown/>)

- Resurfacing of existing asphalt quay to improve functionality and safety for users.
- Removal of overgrown vegetation on the pier to improve safety
- Resurfacing and maintenance of steps down to the river on the west side of the pier
- Replacement of railings for suitable safety

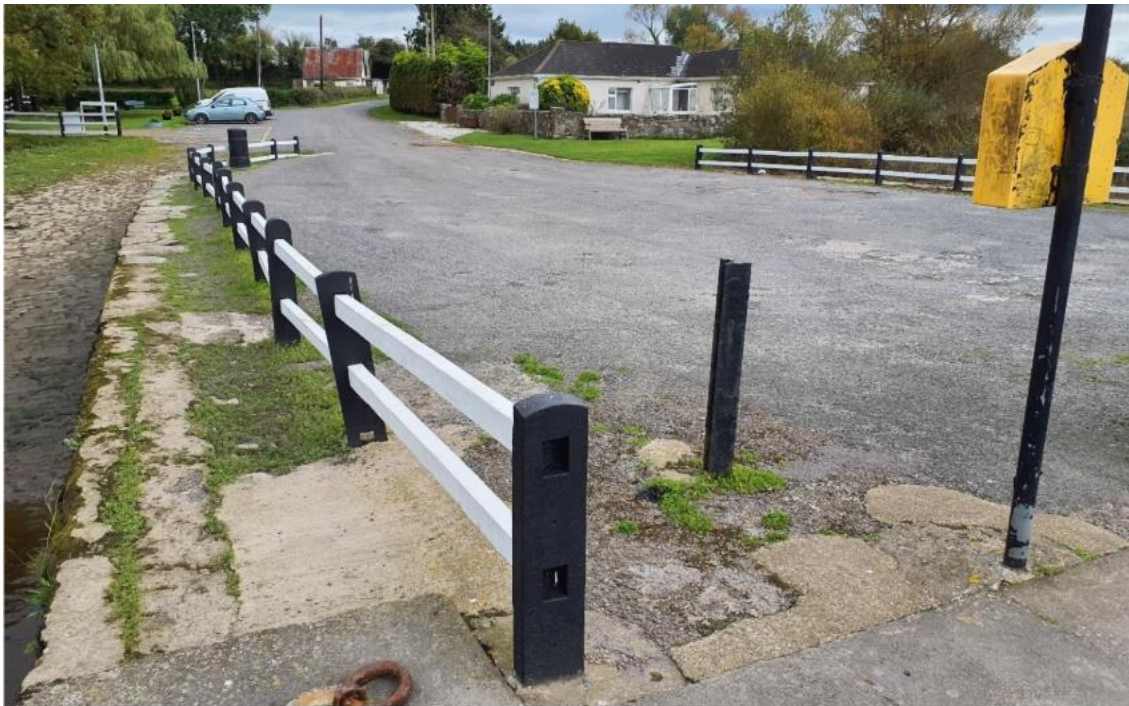
Figure 6: Pier in actuality (<https://consult.waterfordcouncil.ie/en/system/files/materials/2864/AA%20Screening.pdf>)

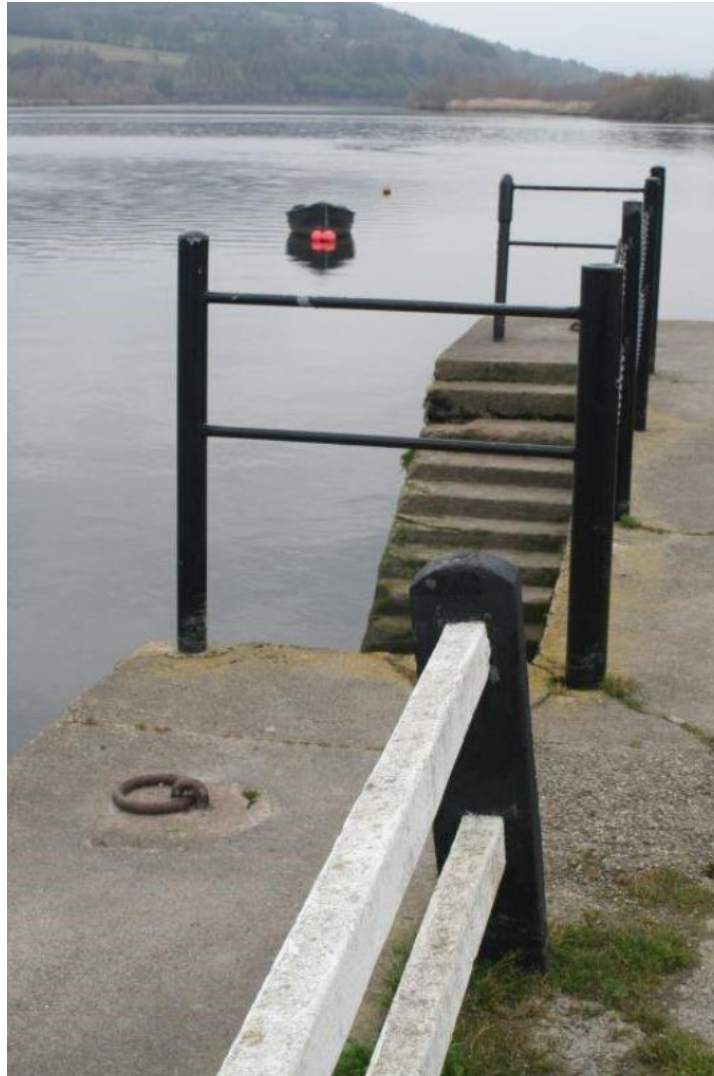
Figure 8: Steps (<https://irishwaterwayshistory.com/abandoned-or-little-used-irish-waterways/waterways-of-cork-and-kerry/the-bride-the-munster-blackwater-and-the-lismore-canal/the-blackwater-by-road/villierstown/>)

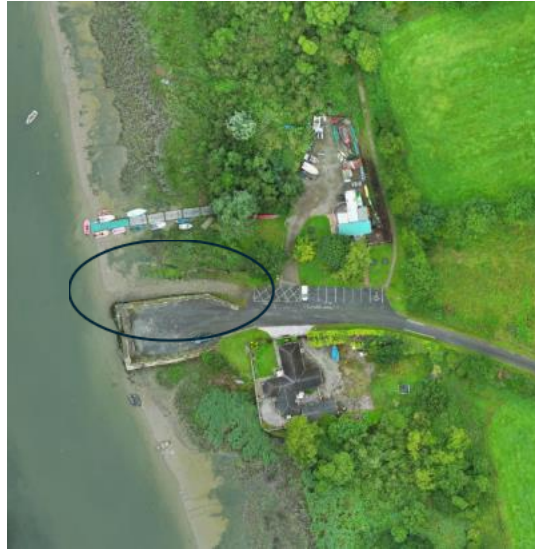
Fig. 1

Currently the slipway stands as an inclined path from the shore to the land, situated adjacent to the pier and the pontoons on the site, seen in Fig.1. “The cobble slipway allows public access to and from the river and may present a challenge to those familiar with modern smooth slipways.”<sup>[6]</sup> as cobble can prove to be difficult to navigate and can be even more difficult in wet conditions, when moss and other vegetation may grow, as well as in cases where users are reliant on walking or mobility supports, like walking sticks, prams or wheelchairs. The slippery moss and mud adjacent to the wall and in between the blocks of cobble can prove to be a hazard for the public as well as those transporting the vessels to and from the water, heightened by the lack of handrail supports.

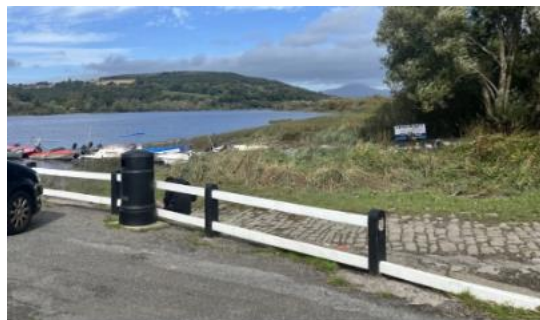
importance historically for docking ferries required to be transported across the Blackwater River and pick up customers and deliver goods to and from Camphire <sup>[7]</sup>. The structure is still in use by locals, visitors and seamen, which is evident from the cobble, grass and mortar being worn down, seen in Fig. 2 & 3.

On our site, there is a notable lack of safety features on the slipway. Features such as tactile paving materials and handrails would be of use for those accessing the river for recreational use.

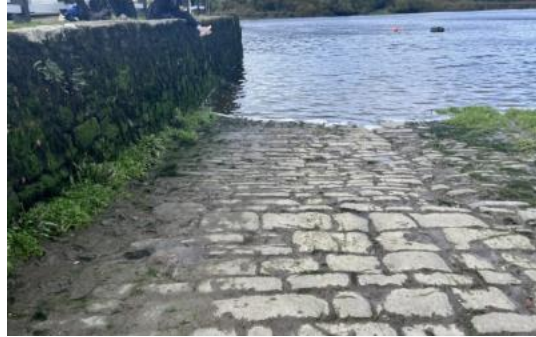
Fig. 3

There isn't many notable cracks or fissures in the cobble, however, through constant use over many years, the cobble has lost much of its grip and poses tactile problems for users. The degraded mortar and mud being transferred from the hull of vessels and other vehicles adds to the slip factor on the slipway, seen in Fig. 3.

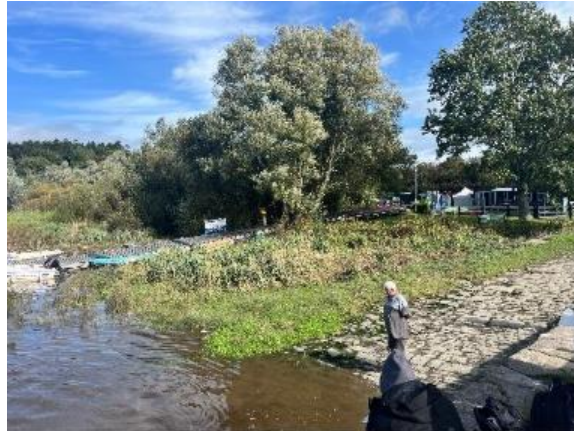
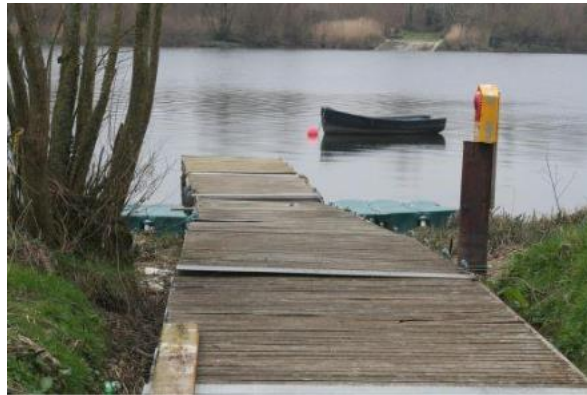
As we can see the wood is in a constant degradation state due to weather conditions and its conditions of use. The current size allows only small sized boats to coast on.

As a recommendation, we could consider modernizing the pontoon, which is showing signs of relatively advanced deterioration. Replacing the pontoon should ensure that it remains easy to dismantle and has a low visual impact on the landscape. The objective would be to find a compromise between the size and capacity of the pontoon to optimize users' nautical activities while avoiding any distortion of the river's natural character.
